# CHICKEN HOUSE/WASH HOUSE

**Carl Sandburg Home NHS**  
Flat Rock, North Carolina

## HISTORIC STRUCTURE REPORT

**September 2007**

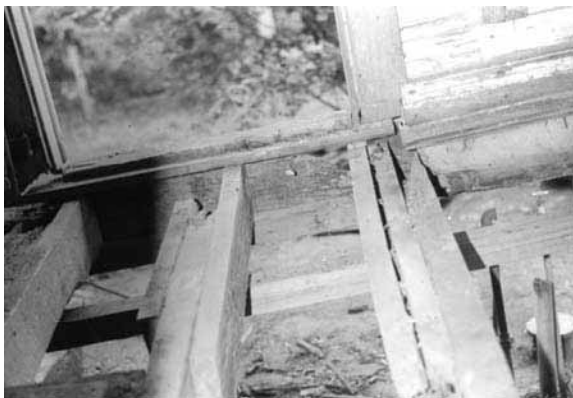
**Figure B-10** Flooring removed in Kid room to facilitate joist repairs, Haynes, 1977  
(CARL4007/35/09P)

Photographic documentation of the repair work begins in late 1977 and continues into the following summer. It shows that flooring was removed to facilitate repairs to framing. Dutchman repairs were made to the sills and studs, and many floor joists were sistered.

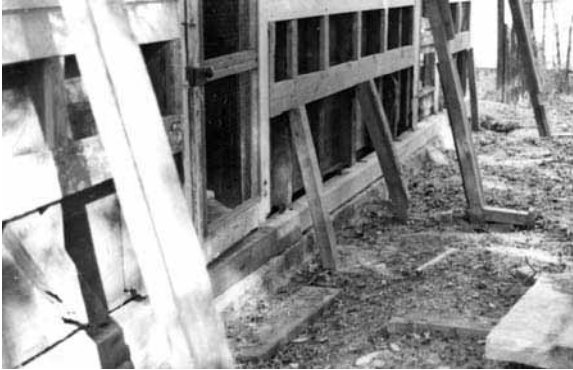
**Figure B-12** Sill repairs on east elevation, summer 1978 (CARL4008/05/59P)

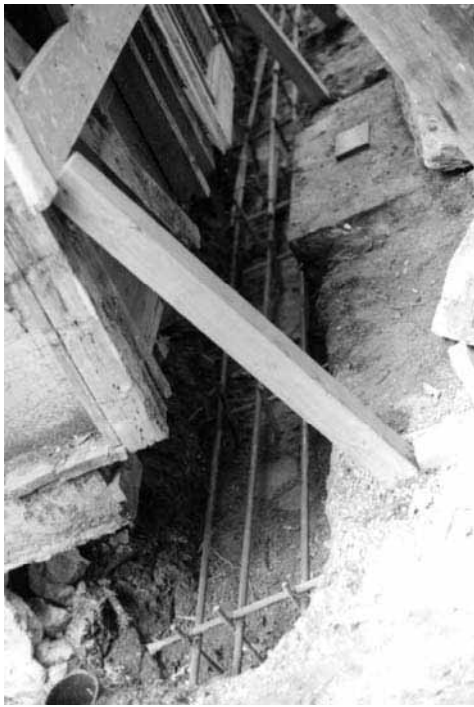
**Figure B-13** New reinforced concrete footings, November 10, 1977 (CARL4008/05/35P)

Some siding was removed as well, and it is not known whether any of the removed siding was reinstalled or if new siding was used in its place. The building was shored up and the stone foundation completely removed. A reinforced concrete spread footing was poured, and the foundation rebuilt. It is not known if the original foundation stones were re-used, but it seems likely.

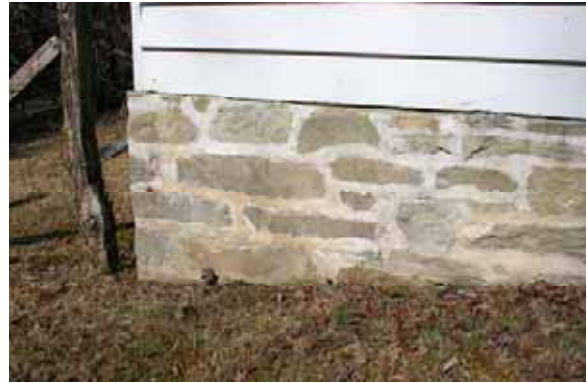
**Foundations & Cross Walls:** The perimeter foundation walls are made of randomly-coursed blocks of granite, and they were rebuilt in the 1970s work. It is not known if the original stones were reused, though it is likely. Photo-documentation indicates that poured-in-place concrete footings were installed at that time.

*Figure C-3 Stone foundation near west corner of south elevation*

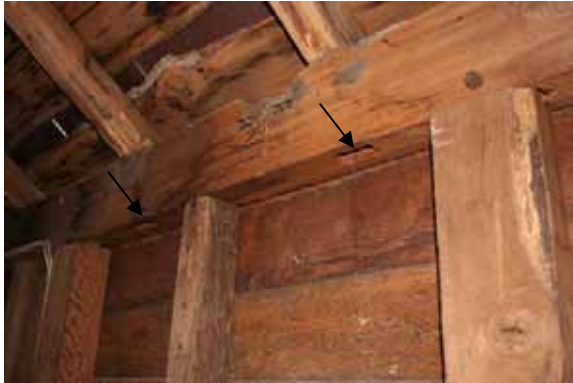
members which are toenailed into the plate. There are empty mortises adjacent to the newer vertical posts.

*Figure C-5 Larger vertical members mortised into top plate at sides of photo, newer vertical in center toenailed, and empty mortises adjacent*

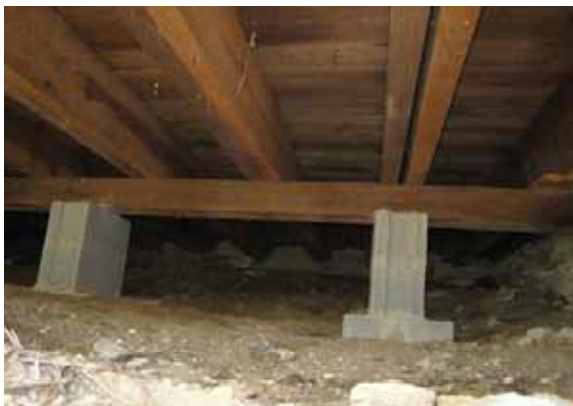
**Flooring Systems:** The first-floor framing consists of 2 7/8" by 10" floor joists spaced at 23" on center and spanning the full dimension of the building from east to west. All floor joists were sistered in the 1970s repairs with 2 3/4" by 10" new joists. Also, during these repairs a new 5 1/2" by 5 1/2" girder was added extending north to south at the midpoint of the building; it is supported by modern concrete masonry units in the crawl space.

*Figure C-6 Floor framing with modern sistered joists and CMU supports*

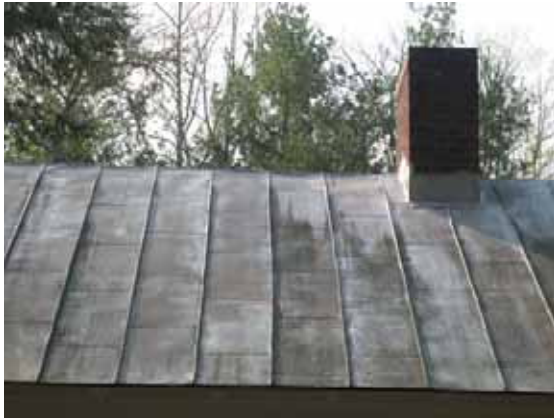
**Roof and Rainwater Collection/Dispersal:** The roofing material consists of standing-seam terne-coated metal roofing, installed in 1978. It replaced a previous metal roof seen in the earliest clear photo of the building, dated c. 1946 in the early years of the Sandburg occupancy

**Figure C-8** Terne-coated metal roofing and stepped chimney flashing

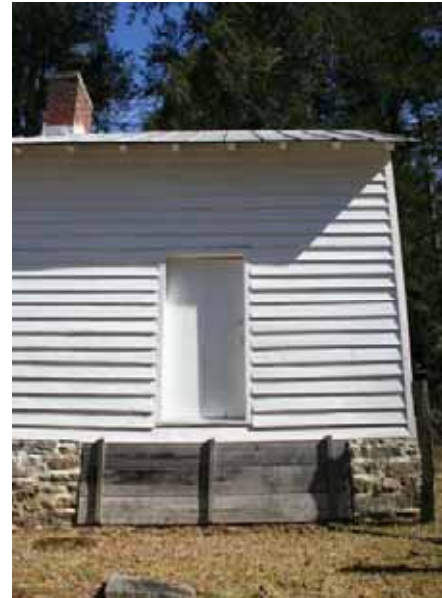
The foundation walls consist of randomly sized blocks of local gray granite set in flush-pointed mortar. The foundation was completely rebuilt in the 1970s repairs, incorporating reinforced concrete footings. It is not known if the original stone was re-used, though it is likely.

**Figure C-9** Wood weatherboard siding and stone foundation walls, west elevation
